Case Study – Hitachi OEM Electrical Cabinet

Finding the solution to reducing those re-occurring electrical faults and solving the issue with finding a suitable relay for the Hitachi EX1900, 3600, 5500 & 5600 excavators.

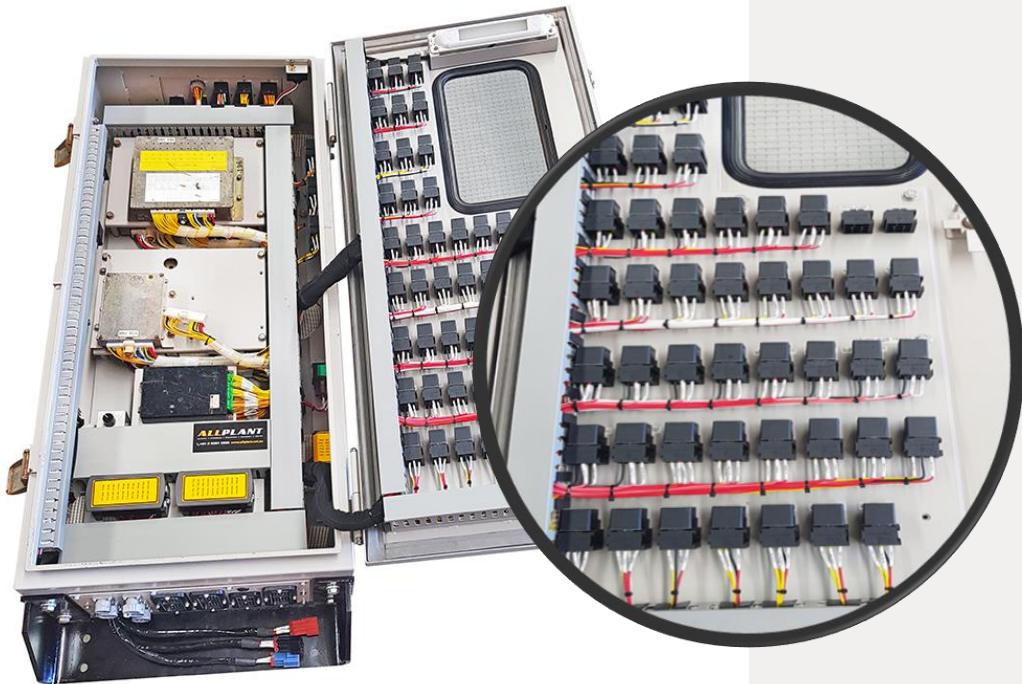
With the extreme environmental challenges and parts availability, the Hitachi OEM main electrical cabinets are a common factor in electrical downtime issues. The factory relays found in these units are an OEM only component and finding replacements on site can be challenging for service personnel and management.

Utilizing a service exchange cabinet, the OEM electrical cabinet can be changed out during a planned maintenance shut down, resulting in no additional downtime. The new exchange unit is not only fully refurbished it features upgraded wiring in problematic circuits and a complete relay upgrade, to BOSCH 5 pin relays and bases. This is an important feature to our customers, giving them access to use a standard size 5 pin relay readily available on site.

- Sand blast and paint cabinet
- Full wiring replacement as per OEM and wiring size upgrade to critical circuits
- Upgrade to BOSCH relays and base's
- Workshop tested to ease site installation
- New cable ducting
